WESTERN GEAR CORPORATION

REPORT NO. 7003-310

PRECISION FORGING OF STIRAL BEVEL GEARS
FOR ARMY HELICOPTERS

FINAL REPORT

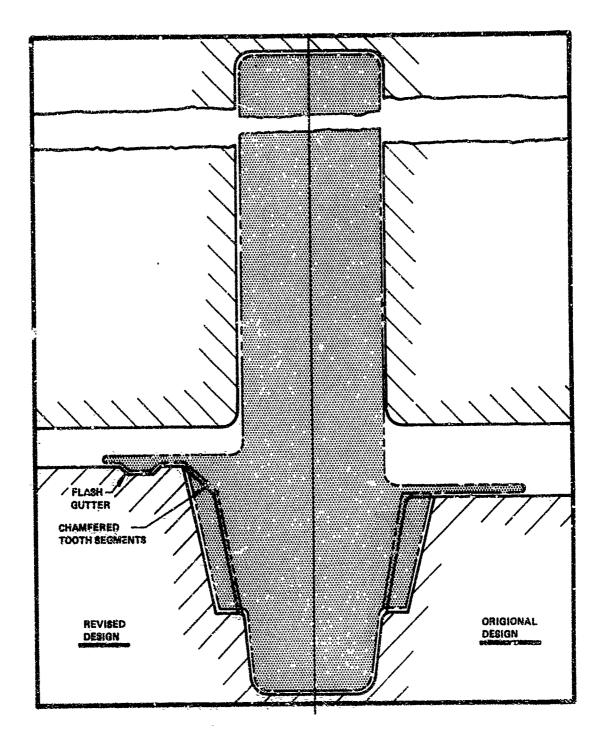
Figure 16. Damaged Pinion Block Die

The initial twenty piece developmental forging run of the shank shaft spiral bevel pinion resulted in gross damage to both the block and finish dies. The type and location was the same as that which occurred in the 44 tooth gear dies. The deformation was greater in magnitude and developed earlier. Several teeth had segments broken off. The damaged block die is shown in Figure 16.

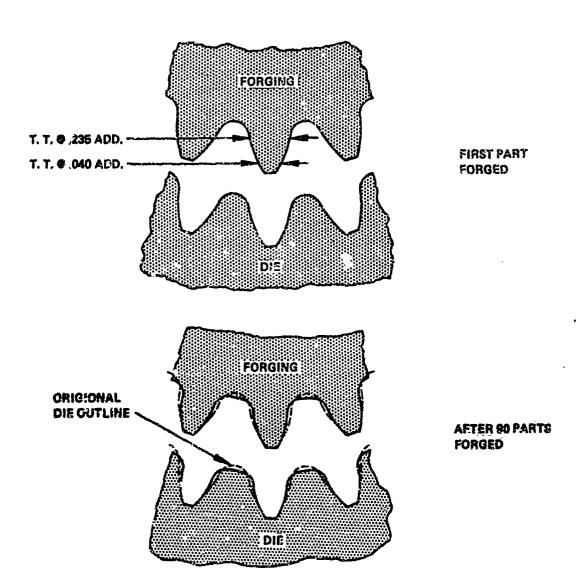
Figure 21. Transverse Section Through Die Tooth Element and Forged Tooth Showing the Up-set Die Tooth and the Resulting Effect on the Forged Pinion Tooth Geometry

mode of up-set deformation that recurred to the die tooth profile and is illustrated schematically in Figure 21.

The large amount of tooth deformation experienced in the forgings can be attributed to two causes:

- a. The spiral tooth geometry, especially in conjunction with the small cone angle of the pinion causes intolerably large forces on the tooth part of the forging die.
- b. The deleterious tempering effect caused by excessive dwell time of the hot forged part in the die cavity. In subsequent meetings with several forging experts, it was generally agreed that one second was the maximum time the forging could be in intimate contact with the die material without harmful rects.
